# Investigation of Sideband Index Response to Prototype Gear Tooth Damage

*Paula J. Dempsey*  
*Glenn Research Center, Cleveland, Ohio*

The objective of this analysis was to evaluate the ability of gear condition indicators (CI) to detect contact fatigue damage on spiral bevel gear teeth. Tests were performed in the NASA Glenn Spiral Bevel Gear Fatigue Rig on eight prototype gear sets (pinion/gear). Damage was initiated and progressed on the gear and pinion teeth. Vibration data was measured during damage progression at varying torque values while varying damage modes to the gear teeth were observed and documented with inspection photos. Sideband indexes (SI) and root mean square (RMS) CIs were calculated from the time synchronous averaged vibration data. Results found that both CIs respond differently to varying torque levels, damage levels and damage modes.

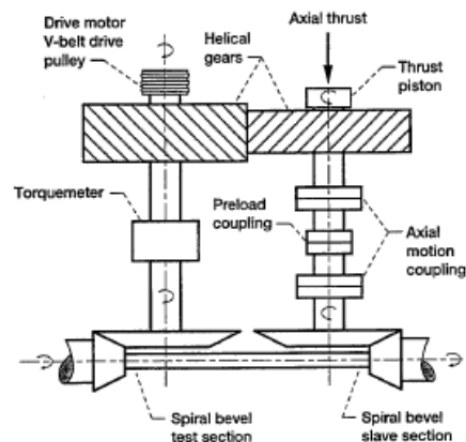
Figure 2.—Cross section of spiral bevel gear fatigue rig.

Tests were performed in the Spiral Bevel Gear Test Rig at NASA Glenn Research Center. A detailed description of this test facility can be found in References 3 and 4. The Spiral Bevel Gear Fatigue Rig is illustrated in Figure 1. In addition to developing gear health monitoring tools, the test facility has been used to study the effects of gear material, gear tooth design, and lubrication on the fatigue strength of gears. Two sets of spiral bevel gears are installed in the test rig and tested simultaneously. Facing the gearboxes per Figure 1, the left gear set (pinion/gear) is referenced as left and the right gear set (pinion/gear) is referenced as right within the paper.

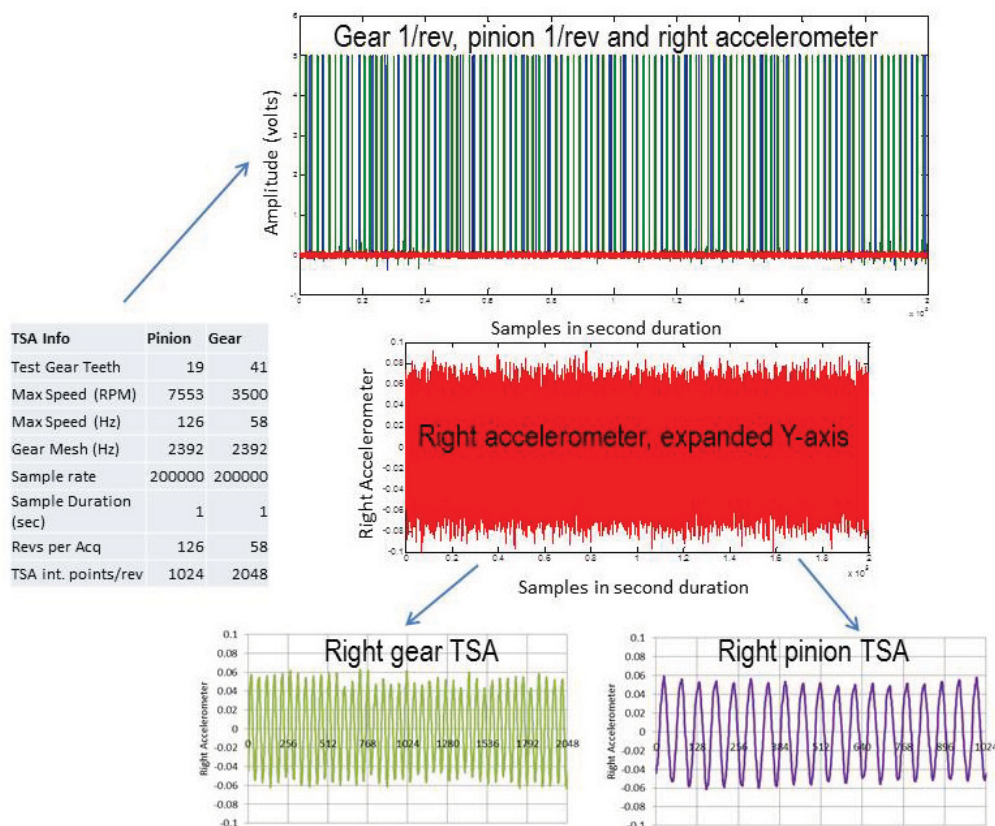
Figure 3 illustrates the information used to calculate the TSA for the right gear and pinion. Using the sample rate of 200 KHz for 1 sec duration and the speed of both shafts, the number of TSA averages for each acquisition is determined. Each average consists of 1 revolution of the shaft. Each average is made up of the number of linearly interpolated points rounded down to a power of two. A power of two is used because it eases the future use of the Fast Fourier Transform (FFT) to transform the time domain signal for the time domain to the frequency domain. Per Figure 3, the top figure displays the right accelerometer data sampled for one second at 200,000 samples/second. The green and blue lines are pulses from the gear and pinion 1/rev signal measured for each shaft rotation during this one second period. Only the right accelerometer is plotted in the next figure with an expanded y-axis scale. The two lowest plots are the TSA signal calculated from the 1/rev and vibration data for the right gear and pinion. Pulses from the 41 tooth gear and the 19 tooth pinion can easily be seen within these two plots.

Figure 3.—Information used to calculate TSA.

Figure 5 illustrates the steps required to calculate RMS and SI for each reading. RMS uses the interpolated TSA data per Figure 3 to calculate the RMS of the TSA. SI uses the TSA to calculate an FFT. Then the amplitudes of the FFT on either side of the gear mesh (GM) are used to calculate SI indexes. Note that the x-axis of the plot showing the FFT of the right gear is in shaft orders or multiples of shaft speed. For example, since the gear has 41 teeth, the gear mesh frequency (teeth x rpm) shows up at 41 shaft orders.

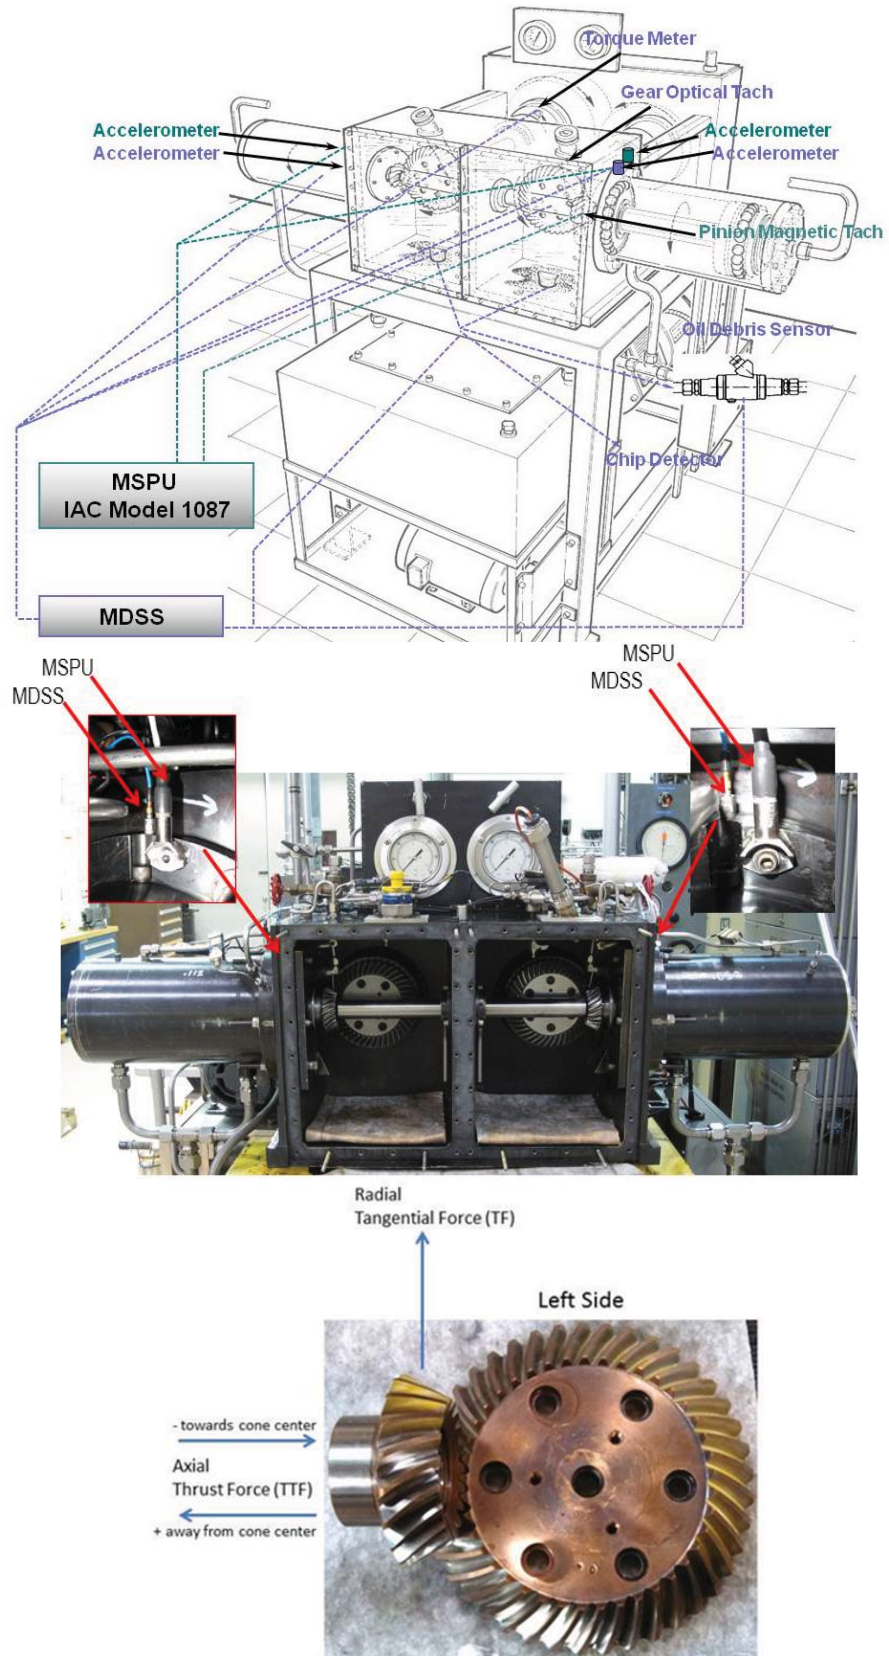
For the first test, the MSPU accelerometers were mounted on the housing, axially and horizontally with respect to the pinion. At completion of the test it was determined that this location had a poor response to the gear mesh vibration signatures through analysis of the TSA data. For the remaining three tests, the accelerometers were mounted on the housing, in close proximity to the MDSS accelerometers, radially and vertically with respect to the pinion, as shown in Figure 4. The TSA data had a good response to the gear mesh vibration and correlated well with the MDSS data at this location. The thrust and tangential forces at the mesh of the spiral bevel gear design were also calculated from the gear set operating conditions and found the tangential force in the radial direction significantly larger than the thrust force in the radial direction indicating a larger amplitude in the radial vertical orientation. This is illustrated in Figure 4.

Figure 4.—Location of accelerometers.

For the MSPU system, accelerometers are also installed on the right and left side of the test rig. Accelerometer frequency range is 0.5 to 5 KHz with a resonant frequency of 26 KHz. A magnetic tachometer is installed on the right pinion and measures pinion pulses per tooth pass. This is used to calculate the TSA for both the pinion and the gear. The gear ratio is used to process the data at the correct speed for the gear.

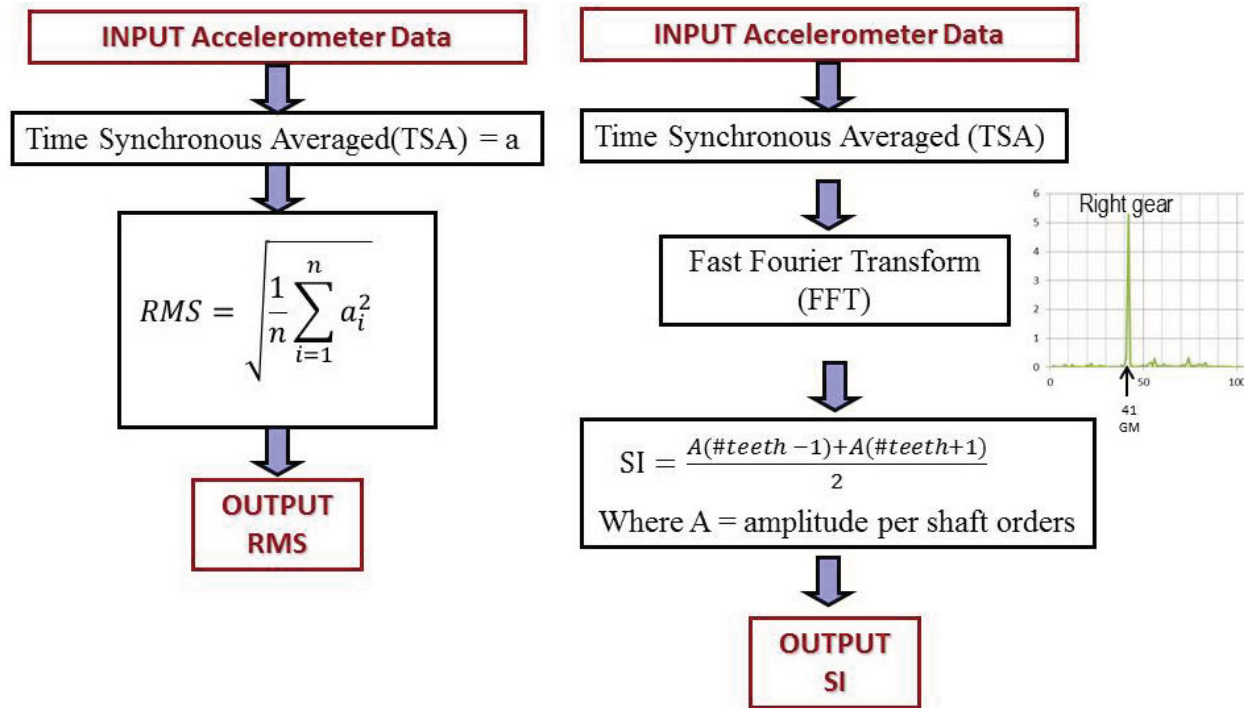
Figure 5.—RMS and SI calculations.

Condition indicator (CI) SI was calculated for the left gear, left pinion, right gear and right pinion. For this CI, the time synchronous average data is converted to the frequency domain, then the amplitude of the average sidebands on either side of the gear mesh are trended. The MDSS system averages the amplitude of  $\pm 1$  sideband on either side of the gear or pinion mesh to calculate its SI CI. The MSPU system averages the amplitude of  $\pm 3$  sidebands on either side of the gear or pinion mesh to calculate its SI CI. For example, the pinion gear mesh is 19 times the rpm of the pinion. The MSPU system averages the amplitude of  $\pm 3$  sidebands ( $16 \times \text{rpm}$ ,  $17 \times \text{rpm}$ ,  $18 \times \text{rpm}$ ,  $20 \times \text{rpm}$ ,  $21 \times \text{rpm}$ , and  $22 \times \text{rpm}$ ) to calculate SI.

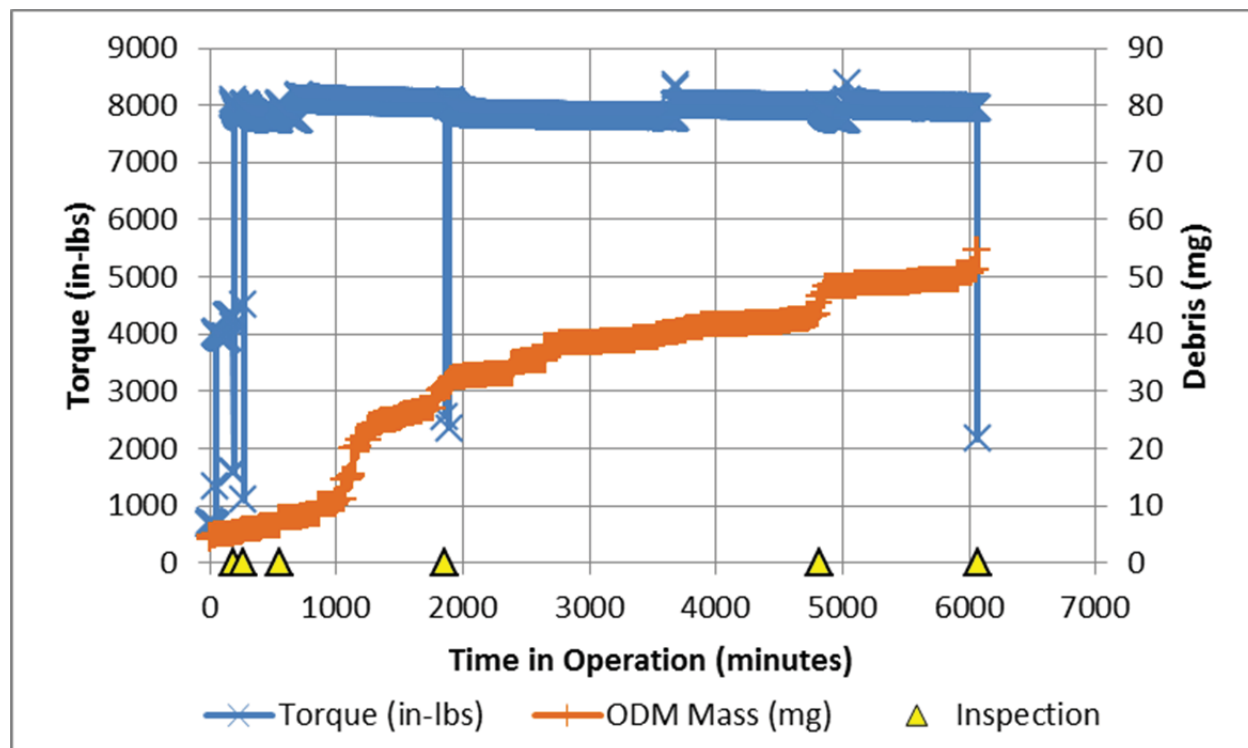
For test 1, per Figure 6, the rate of debris generation measured was 1.9 mg/hr at reading 1862, when spalling macropitting (4.3.4) was first observed on one left pinion tooth, although per Table 2, other types of damage occurred during this inspection interval on the right gear teeth. The rate decreased to 0.4 mg/hr when macropitting was observed on all of the teeth.

Figure 6.—Debris generated and torque during test 1.

Figure 6 is a plot of debris generated and the torque during test 1. Figure 7 is a plot of RMS during test 1. Tooth damage photos for the gear and pinion during the inspection intervals can be found in Figures A.1.1 to A.1.5.

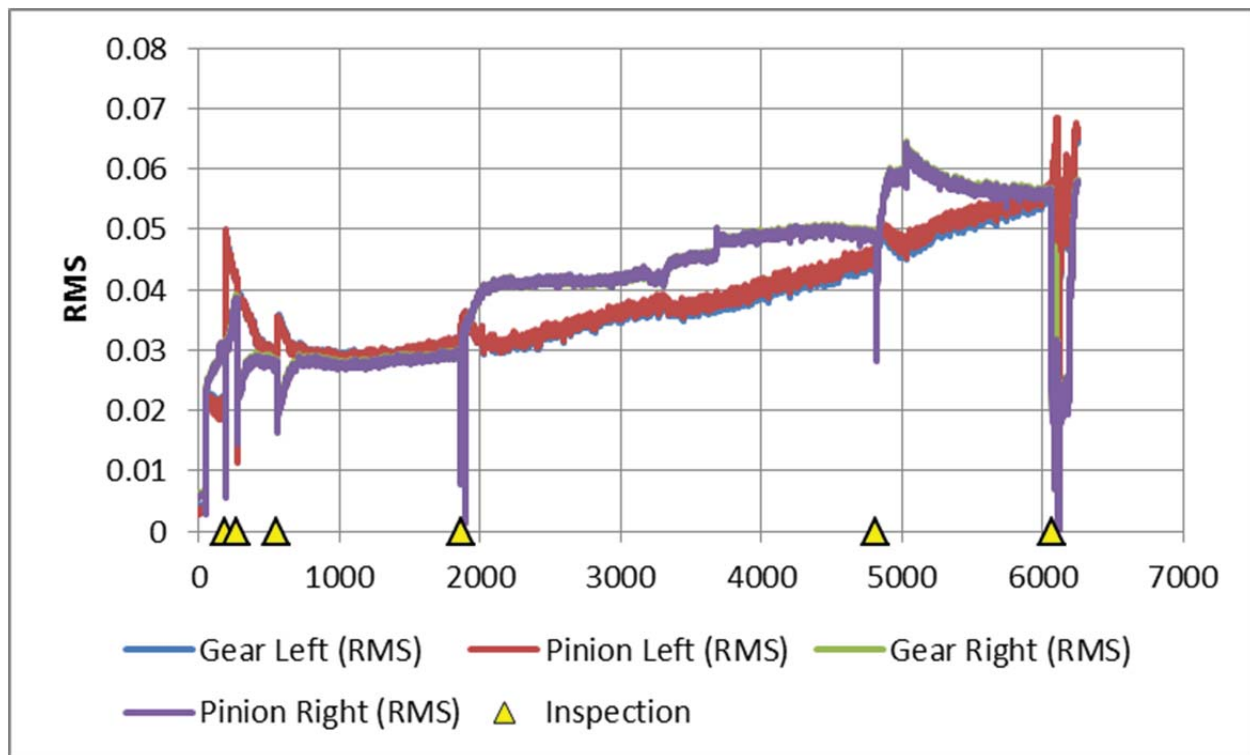
Figure 7.—RMS during test 1.

Per Figure 7, RMS could not be used to isolate the pinion from the gear on the left and right side of the test rig. The left gear and pinion RMS values tracked each other very closely as did the right gear and pinion. Both responded to the restarts after inspections, but the right side was significantly more sensitive than the left. The left RMS values trended well with damage progression.

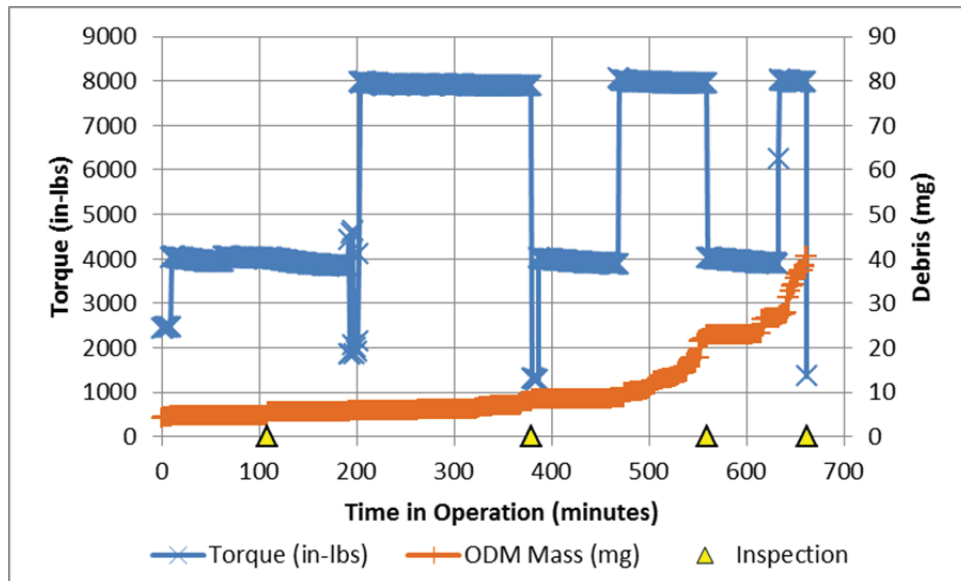
Figure 8.—Debris generated and torque during test 2.

Figure 8 is a plot of debris generated and the torque during test 2. Figure 9 is a plot of RMS during test 2. Tooth damage photos for the gear and pinion during the inspection intervals can be found in Figure A.2.1.

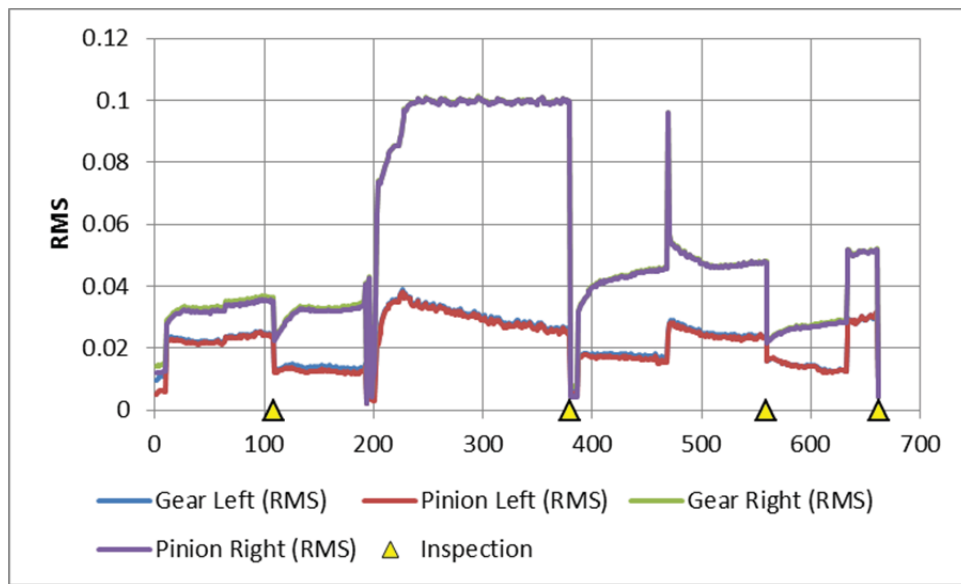
Figure 9.—RMS during test 2.

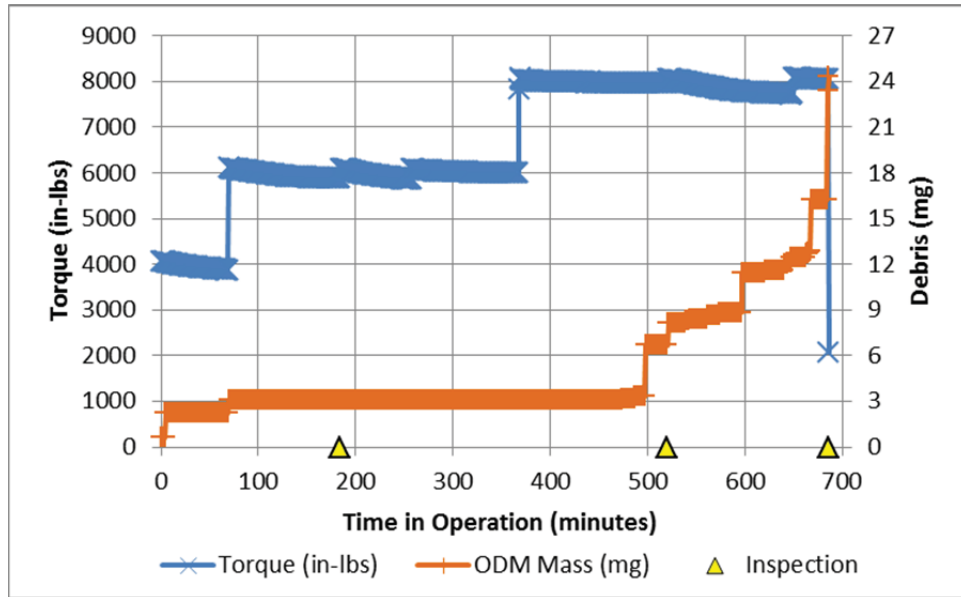
For test 3, per Figure 10, the rate of debris generation measured increased when torque increased from 6,000 to 8,000 in.-lb. For this test, the torque was not decreased when the macropitting was observed on the teeth. The 6.37 mg/hr rate of debris generation when spalling macropitting (4.3.4) was observed at 8,000 in.-lb was higher than the 3.75 mg/hr rate of debris generation when spalling macropitting (4.3.4) was observed at 4,000 in.-lb for test 2.

Figure 10.—Debris generated and torque during test 3.

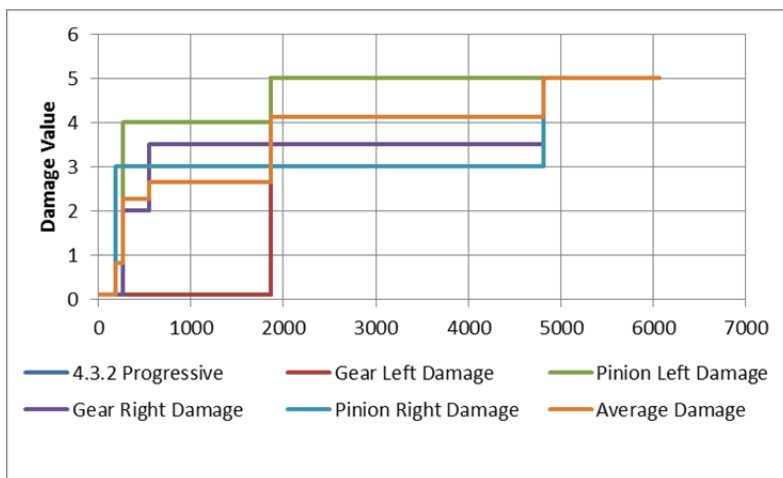
Damage values based on component tooth damage were generated for each reading for each test. Figure 14 is a plot of the damage values from Table 15 for test 1. An average damage value was also calculated for all 4 components for each reading. A fifth parameter, referred to as 4.3.2 Progressive, is a damage value when progressive pitting was observed on two or more teeth on any of the four components. For example, during test 1, this value was 0.1 until reading 1862. After this reading, the damage value remained at 5 for the rest of the test. Values were assigned and used to determine the sensitivity of the CI to this specific failure mode. Also note for tests 2 and 3, the torque changed within an inspection interval. Further work is required to optimize the values or classify and cluster them with additional information.

Figure 14.—Damage values for test 1.

To perform the assessment required assigning a continuous monotonic increasing value to the different damage modes observed during each inspection interval. The values chosen for each test are listed in Table 15. The values were chosen based on the level of damage and the damage of the most interest for this study. A value of 0.1 was assigned to gear teeth broken in with no damage while a value of 5 indicates progressive macro-pitting on two or more gear teeth. Optimization of defining and assigning values to the damage modes for future tests is also planned.

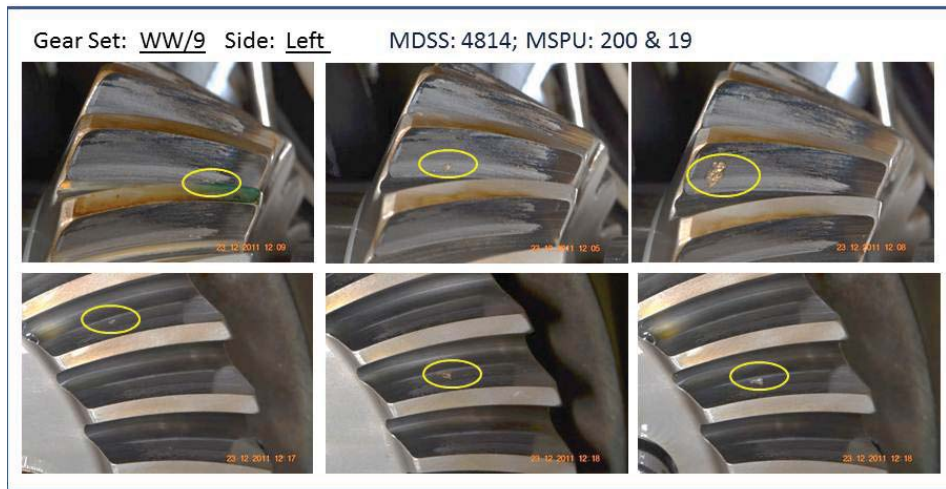
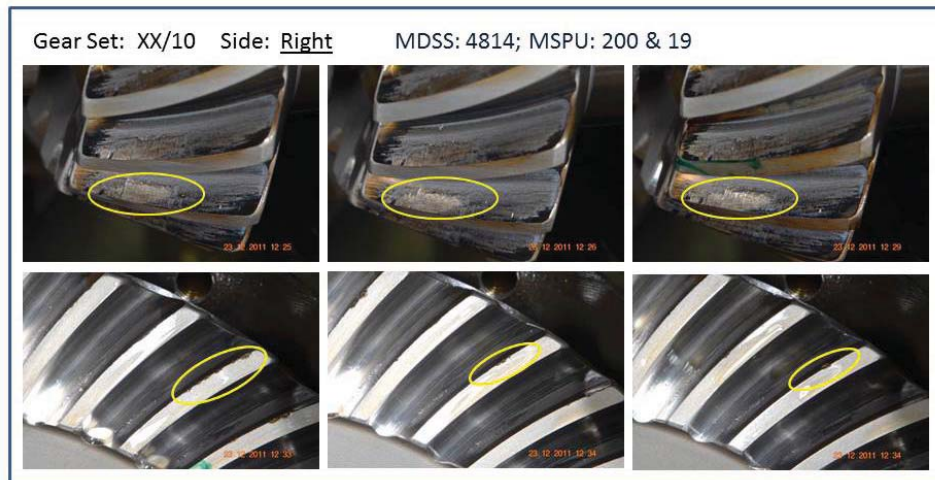
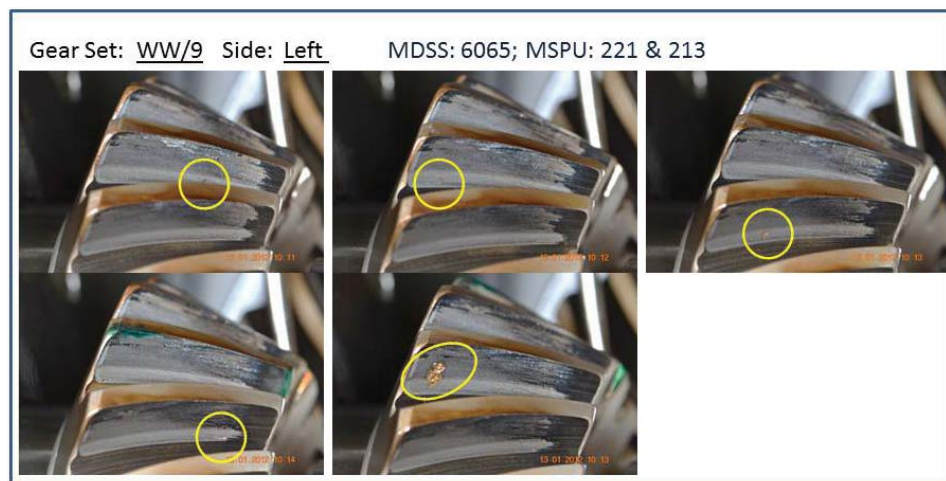
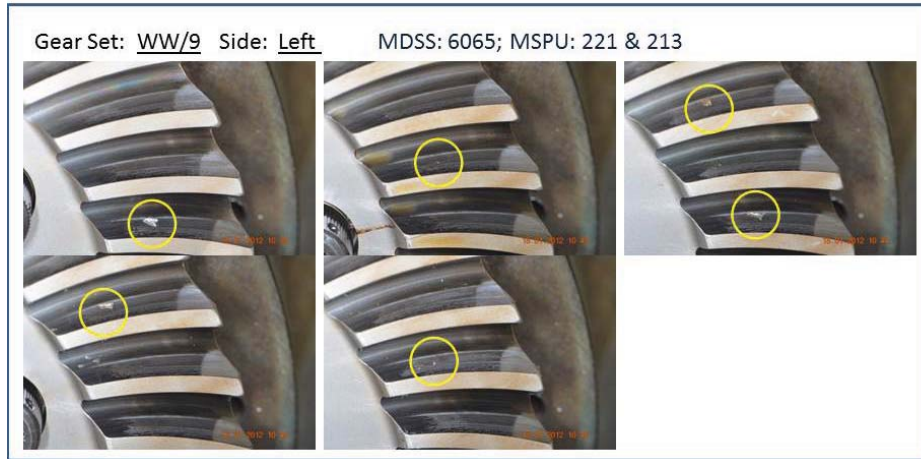
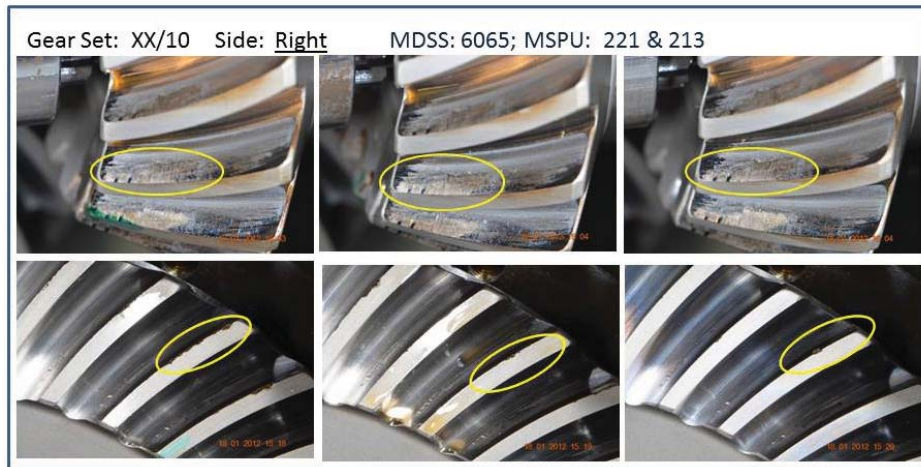
For test 1, Figures A.1.1 to A.1.5 illustrate the progression of damage on the gear and pinion teeth. For the left pinion, macropitting was observed on one pinion tooth at reading 1862 and on two teeth at reading 4814. For the left gear, macropitting was observed on three teeth at reading 4814 and five teeth at reading 6065. Macropitting was also observed on the right gear and pinion at reading 6065, the end of the test.

Figure A.1.1.—Test 1 gear and pinion damage modes.

Figure A.1.2.—Test 1 gear and pinion damage modes.

Figure A.1.3.—Test 1 gear and pinion damage modes.

Figure A.1.4.—Test 1 gear and pinion damage modes.

Figure A.1.5.—Test 1 gear and pinion damage modes.

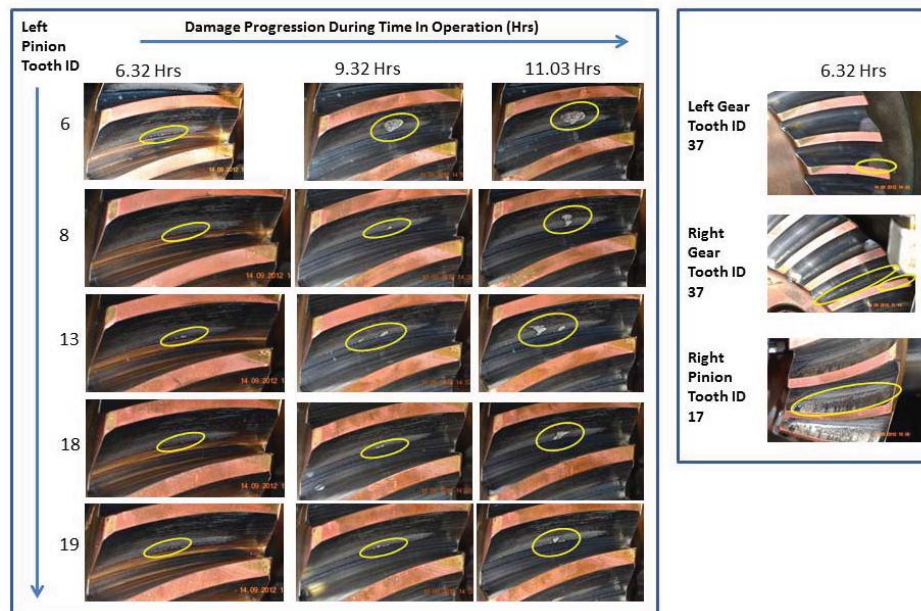
For test 2, Figure A.2.1 illustrates the progression of damage to five left pinion teeth. The other photos are representative pictures of one left gear tooth, on right gear tooth and one pinion tooth. The damage to these gears did not change after the inspection at reading 379. For the left pinion, no macropitting was observed on the pinion teeth at reading 379, 6.32 hours into the test. At reading 559, 9.32 hours into the test, 4.3.4 was observed on two pinion teeth. At reading 662, 11.03 hours into the test, 4.3.4 was observed on five teeth.

Figure A.2.1.—Test 2 gear and pinion damage modes.

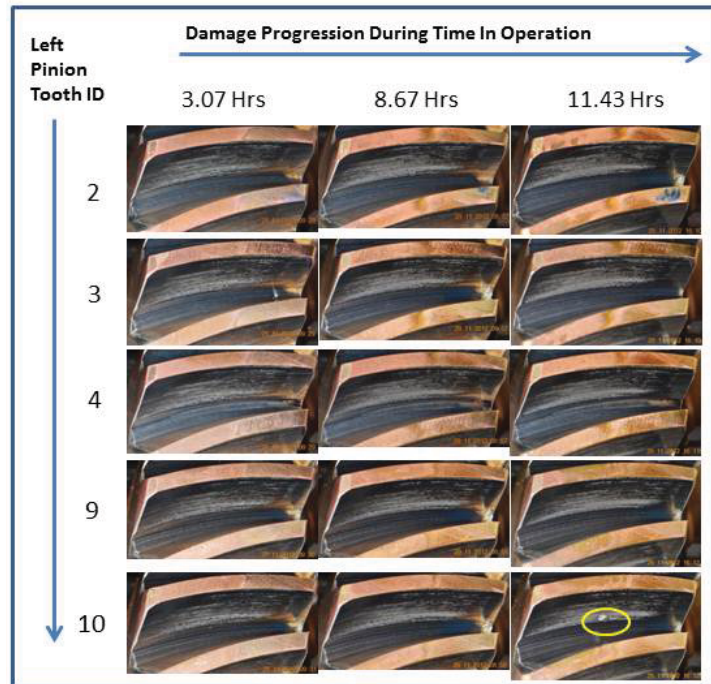
Figure A.3.1.—Test 3 gear and pinion damage modes.

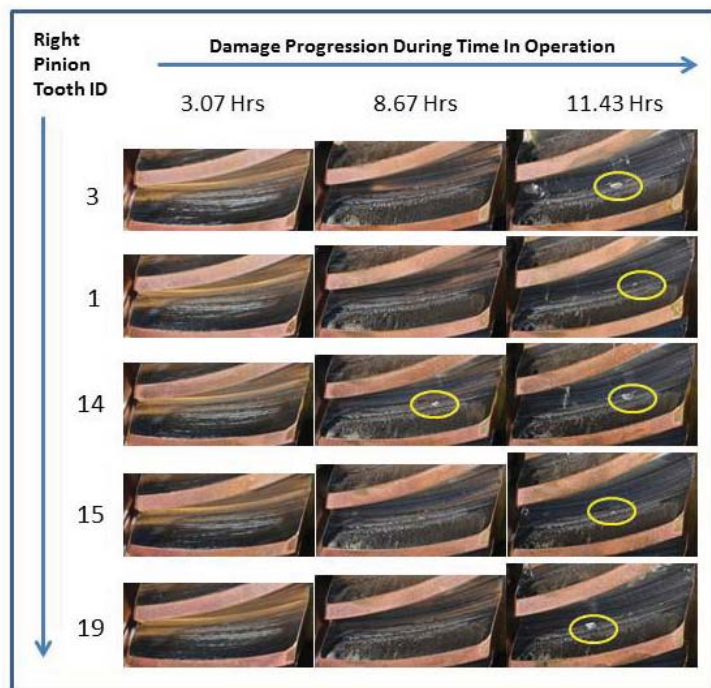
Figure A.3.2.—Test 3 gear and pinion damage modes.

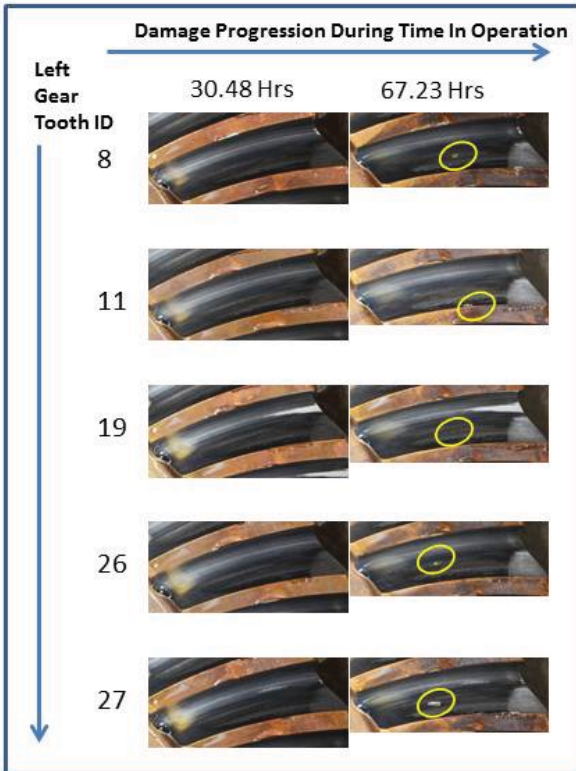
Figure A.4.1.—Test 4 gear and pinion damage modes.

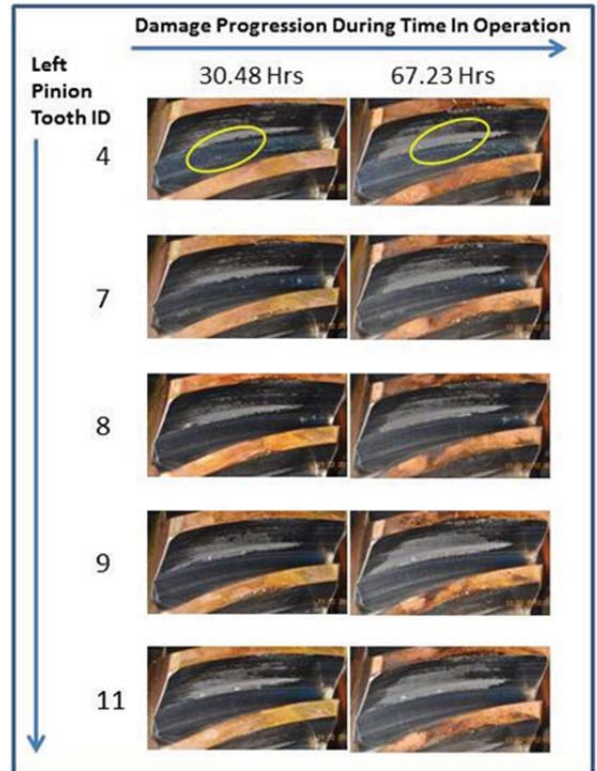
Figure A.4.2.—Test 4 gear and pinion damage modes.

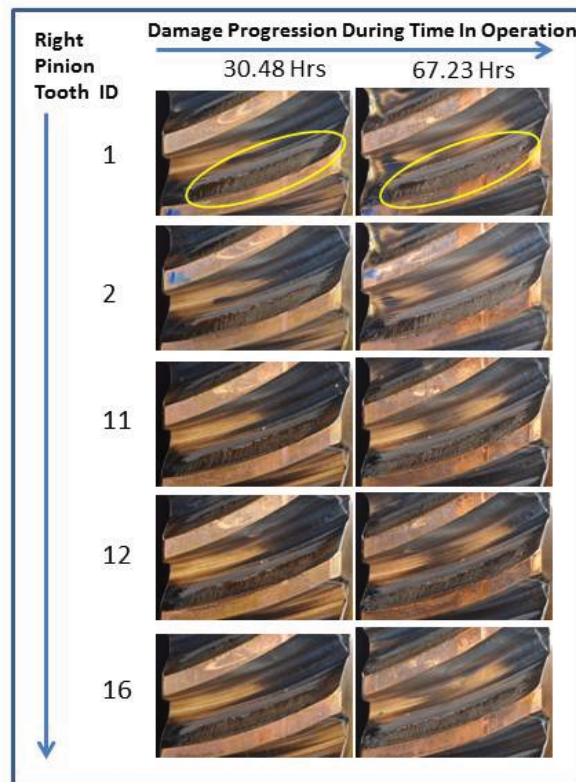
Figure A.4.3.—Test 4 gear and pinion damage modes.

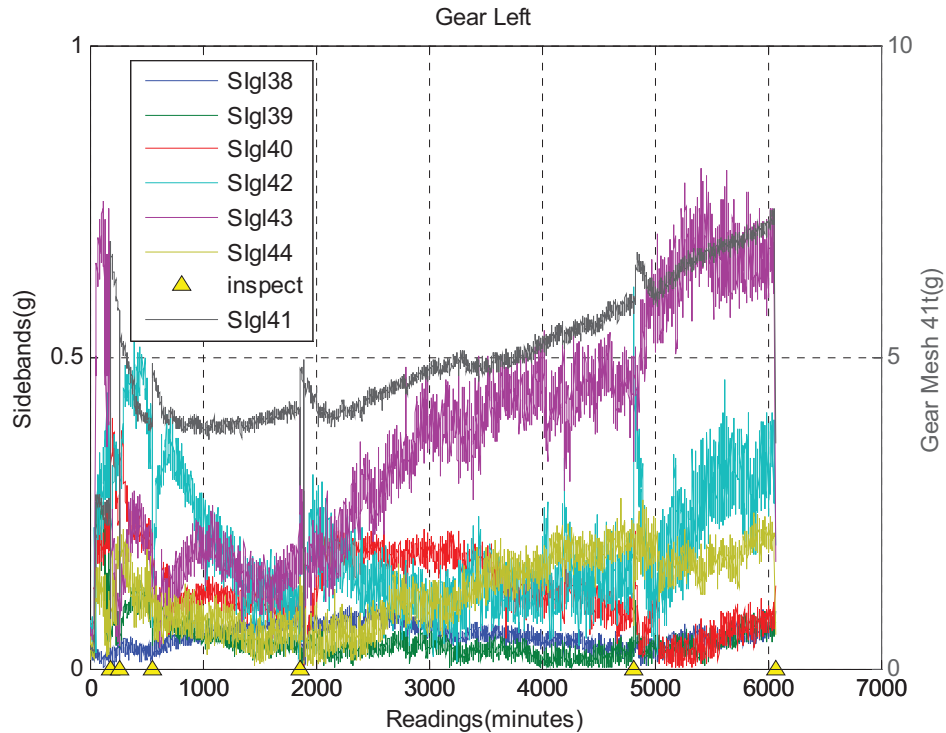
Figure B.1.1.—Test 1 plot of left gear individual sidebands for MDSS.

1. Left gear:
  - a. The +2 sideband (SI43) had the largest value when damage was observed on the gear teeth.
  - b. The +2 sideband (SI43) trended well after gear damage progressed.

- c. The +2 sideband (SI43) had the largest value at lower torque.
  - d. The +1 sideband (SI42) had the largest value when no damage was observed on the gear teeth.

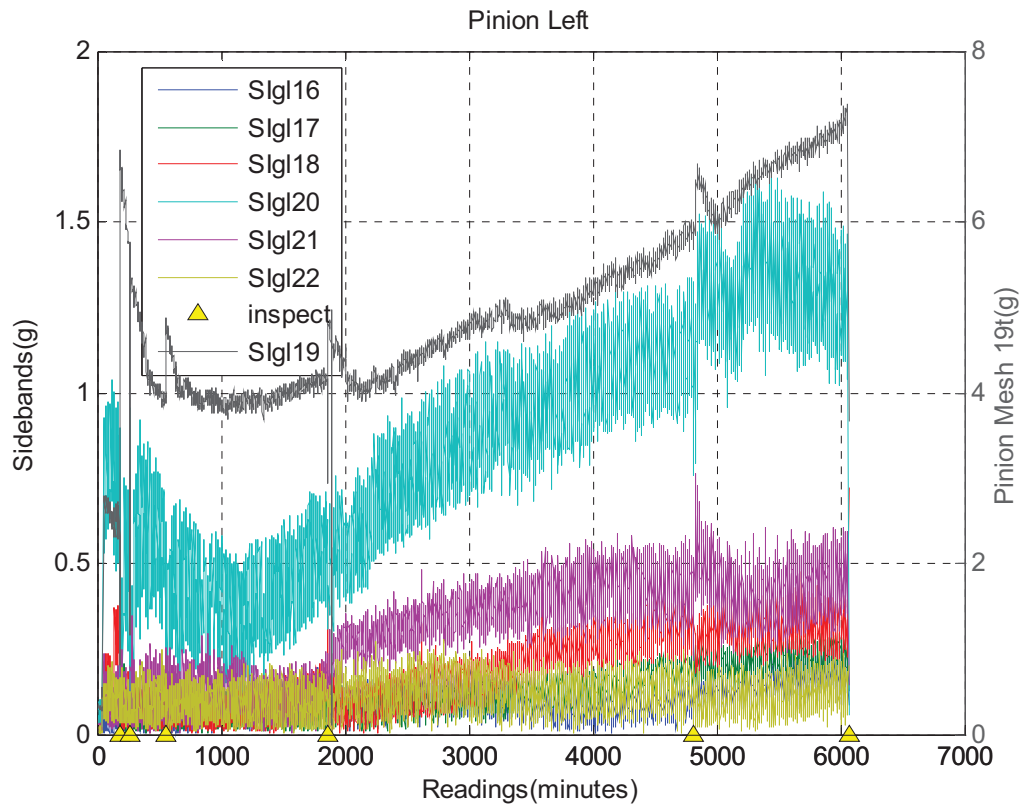
Figure B.1.3.—Test 1 plot of left pinion individual sidebands for MDSS.

- e. The +1 sideband (SI42) trended after gear damage progressed.
2. Left pinion:
  - a. The +1 sideband (SI20) had the largest value throughout the test.

- b. The +1 sideband (SI20) trended well after gear damage progressed to more than one tooth.
  - c. The +1 sideband (SI20) had the largest value at lower torque.

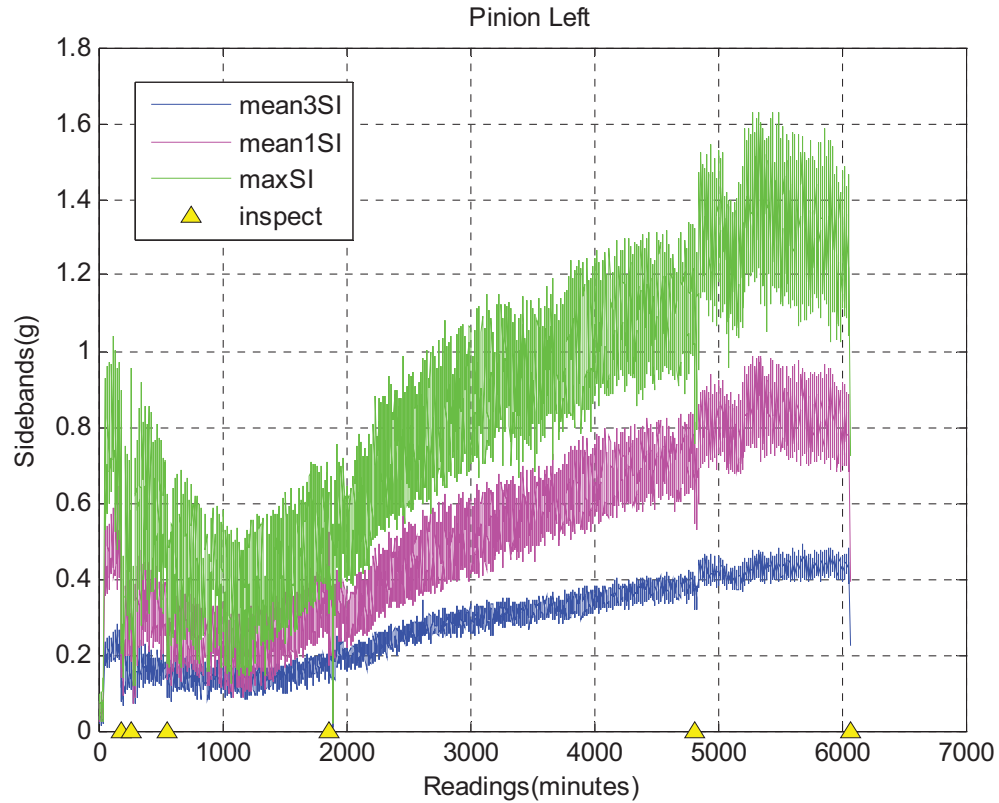
Figure B.1.4.—Test 1 plot of left pinion average and maximum sidebands for MDSS.

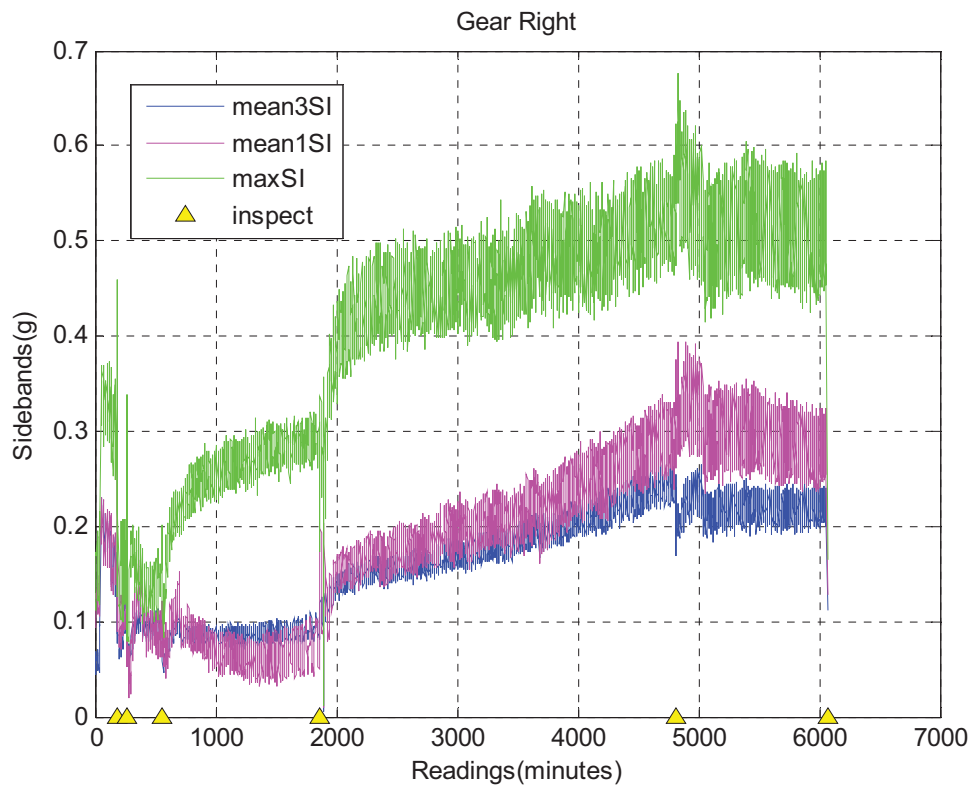
Figure B.1.6.—Test 1 plot of right gear average and maximum sidebands for MDSS.

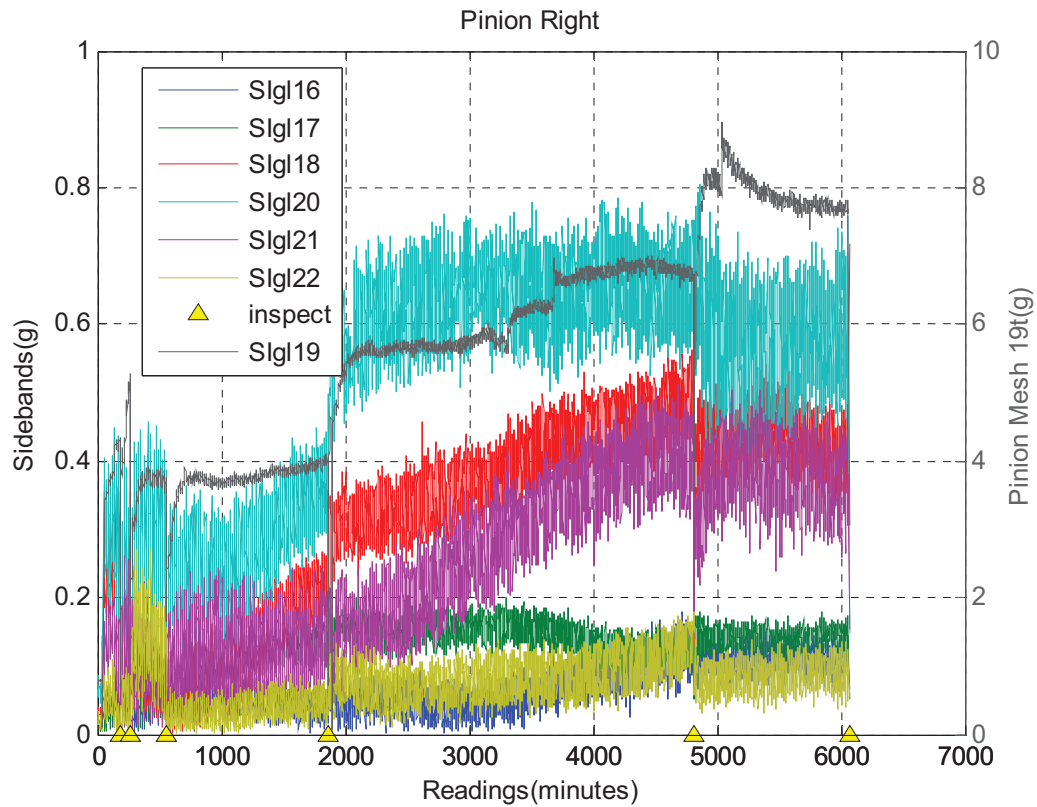
Figure B.1.7.—Test 1 plot of right pinion individual sidebands for MDSS.

- a. The +1 sideband (SI20) had the largest value throughout the test.
  - b. The +1 sideband (SI20) trended well after pinion damage progressed, but dropped slightly after reading 4814.

- c. The -1 sideband (SI18) trended well after pinion damage progressed, but dropped slightly after reading 4814.
  - d. The +2 sideband (SI21) trended well after pinion damage progressed, but dropped slightly after reading 4814.

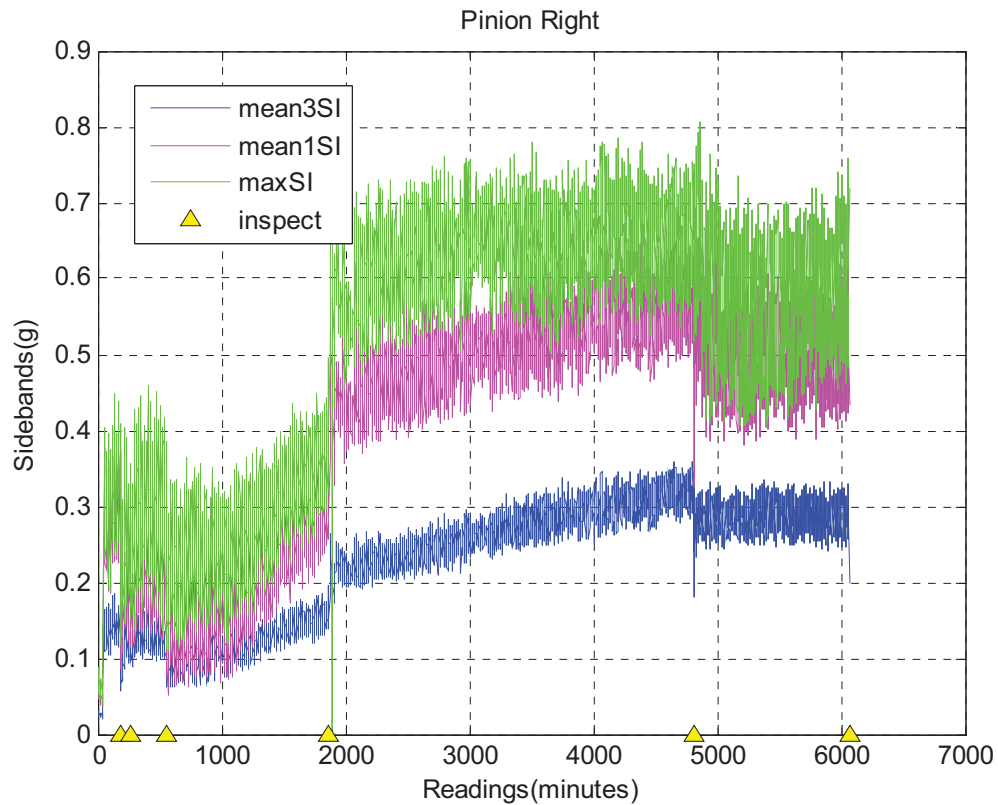
Figure B.1.8.—Test 1 plot of right pinion average and maximum sidebands for MDSS.
